## NAILHEADING

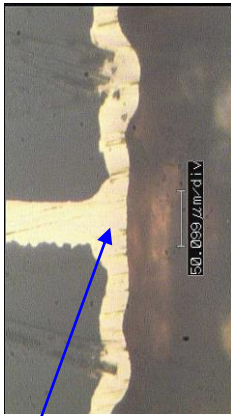
NAILHEADING

The distortion of the copper inner layer at the hole wall, this distortion takes the form of a "Nailhead". There are several types of nailheads; the most common type seen on small hole diameters is a thermal/mechanical nailhead. The thermal/mechanical nailhead is produced by excessive heat and the drill bit pushing and pulling the copper in each direction the drill bit travels. Drill sizes above 0.75 mm diameter are susceptible to thermal/mechanical and only mechanical nailheading. Mechanical nailheading is characterised by a heavy resin smear over the copper.

1. Incorrect infeed.
2. Incorrect spindle speed ( $\text{min}^{-1}$ , RPM).
3. Incorrect retract rate.
4. Under cured resin.
5. Drill bit clogging.
6. High elongation copper.
7. Entry or backer material.

1. Determine type of nailhead, single sided or bi-directional nailheading.
2. Single sided nailheading;  
Reduce infeed rate, or increase  $\text{min}^{-1}$  (RPM).  
Bi-directional nailheading, reduce  $\text{min}^{-1}$  (RPM) or increase infeed rate.
3. On small diameter drills retract rates may be reduced.
4. Check the drill bit for clogging, clogging of the flutes can be caused by drill bit design, aluminium entry sticking to the drill, under cured resin or backer material.
5. High elongation copper foils will increase nailheading, the higher the elongation of the copper the more severe the nailheading will be.
6. Some entry and backer material will adhere the drill bit causing hole wall quality problems.

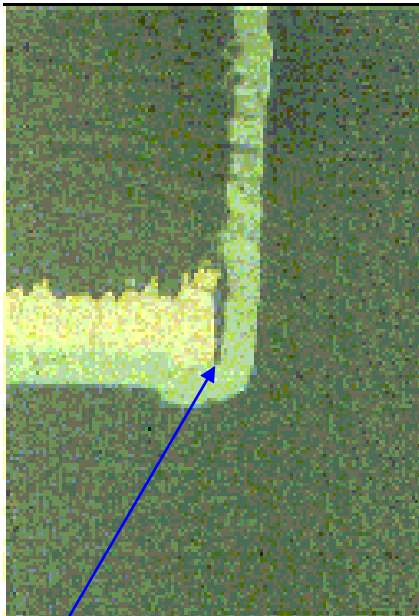
SMEAR

Resin transferred from the base material of the hole wall during drilling covering the exposed edge of the inner layer pad (land). There are two types of resin smear, like nailheading, the thermal mechanical smear is created by excessive heat and is clear in appearance. The mechanical smear is heavy coating over the inner layer land with a colour similar to the resin system being used.

1. Under cured resin.
2. Excessive spindle speed ( $\text{min}^{-1}$ , RPM).
3. Excessive infeed during drilling.
4. Drill depth into backer.
5. Dull drill/chipped drill.
6. Under cured resin in backer material.
7. Incorrect smear removal process.

1. Verify the cure of the resin system.
2. Verify  $\text{min}^{-1}$  (RPM) note, the most common practice to determine correct  $\text{min}^{-1}$  (RPM) is to calculate  $\text{min}^{-1}$  (RPM) for a given drill size based on a pre-determined surface speed per minute formula. The industry standard is 150 m/min., however as the base material becomes harder the SFPM is reduced to 140 m/min., or less.

3. A very high infeed rate while drill will create a heavy resin covering the inner layer copper. This smear will have the same colouring as the base material being drilled. This usually occurs on drill sizes larger than 0.75 mm. The infeed rate is too high, reduce the infeed in increments of 20% until the problem is corrected.

4. Adjust drill depth into backer to proper level, ( $1 \frac{1}{2}$  times the drill diameter). Excessive drill depth into the backer will create unnecessary heat resulting in smear.

5. Dull/chipped drills create heat resulting in smear. Drill should be retired when recommended flank wear land is achieved. Chipping can be caused by improper drill bit handling, incorrect infeed rates, and improper entry materials.

6. Under cured resin in the backer material will transfer to the inner layer conductor.
7. Smear removal processes, which are too weak or spent will not adequately, remove smear. Make necessary additions or increase time in smear removal, or if plasma etch back make necessary changes to gasses and or time in vacuum chamber.

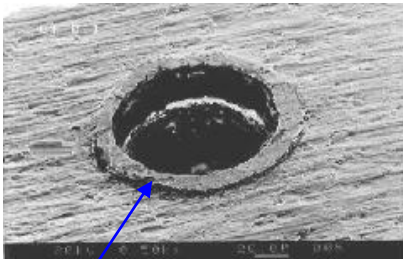
**BURRS**

The distortion of copper foil on the outer layer(s) of the PCB. Burrs may be either entry or exit burrs, and may be visible on both sides of the same panel.

1. Lack of entry material.
2. Entry material too thin for the speeds and feeds being used.
3. Debris entrapment between the entry material and the PCB.
4. The opening in the drill spindle pressure foot is too large, allowing the vacuum to lift the thin entry board.
5. Soft entry material.
6. Poor pressure on the pressure foot.

1. Debris entrapment between the bottom of the panel and the backer board or the next panel in the drill stack.
2. Backer material too soft for material being drilled.
3. Debris clogging the flute of the drill.
4. Poor pressure on the pressure foot.

1. Use entry material on all drill sizes drilled with a chip load in excess of 0.038 mm (for drills used with less than a 0.038 mm chip load, entry material protects the surface of the PCB from damage and to aid the drill for a more accurate penetration of the board material).
2. Replace entry material with a thicker or more ridged material.
3. Clean the surface of the PCB and the entry material of all debris and dust prior to drilling.
4. Replace entry material with a more ridged material or reduce the amount of vacuum being used.
5. Replace the entry with a harder material.
6. Keep the pressure on the pressure foot to a minimum of 120 N.

1. Clean the backer and the bottom of the bottom panel prior to install on drill table. (All material should be wiped off with a tack cloth before placing on the drill table).
2. Replace backer material with a harder material.
3. Correct flute clogging; (resin cure, entry material, backer material, etc.).
4. Keep the pressure on the pressure foot to a minimum of 120 N.
